Navajo Abandoned Uranium Mine

Site Screen Report

Emmett Lee No. 1 AUM Site

January 2011

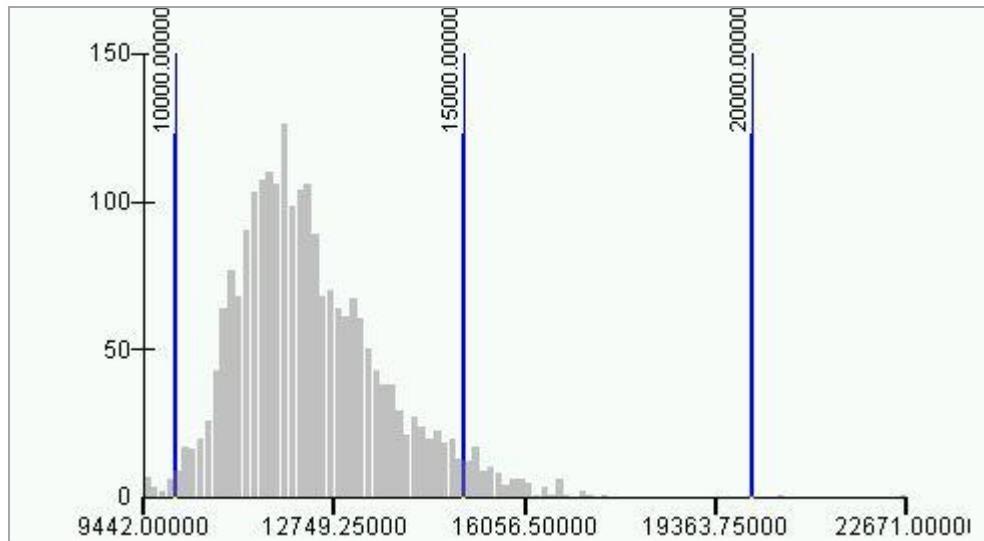
The following chart and statistics were generated by ESRI ArcGIS 9.3.1, and show the general distribution of the site gamma radiation measurements. The horizontal X axis represents the gamma radiation reading levels in cpm (lowest levels to the left). The vertical Y axis represents the frequency of each gamma radiation level.

Count:	2246
Minimum:	9442.00000
Maximum:	22671.00000
Sum:	27734513.00000
Mean:	12348.40294
Median:	12115.00000
Standard Deviation:	1312.26714

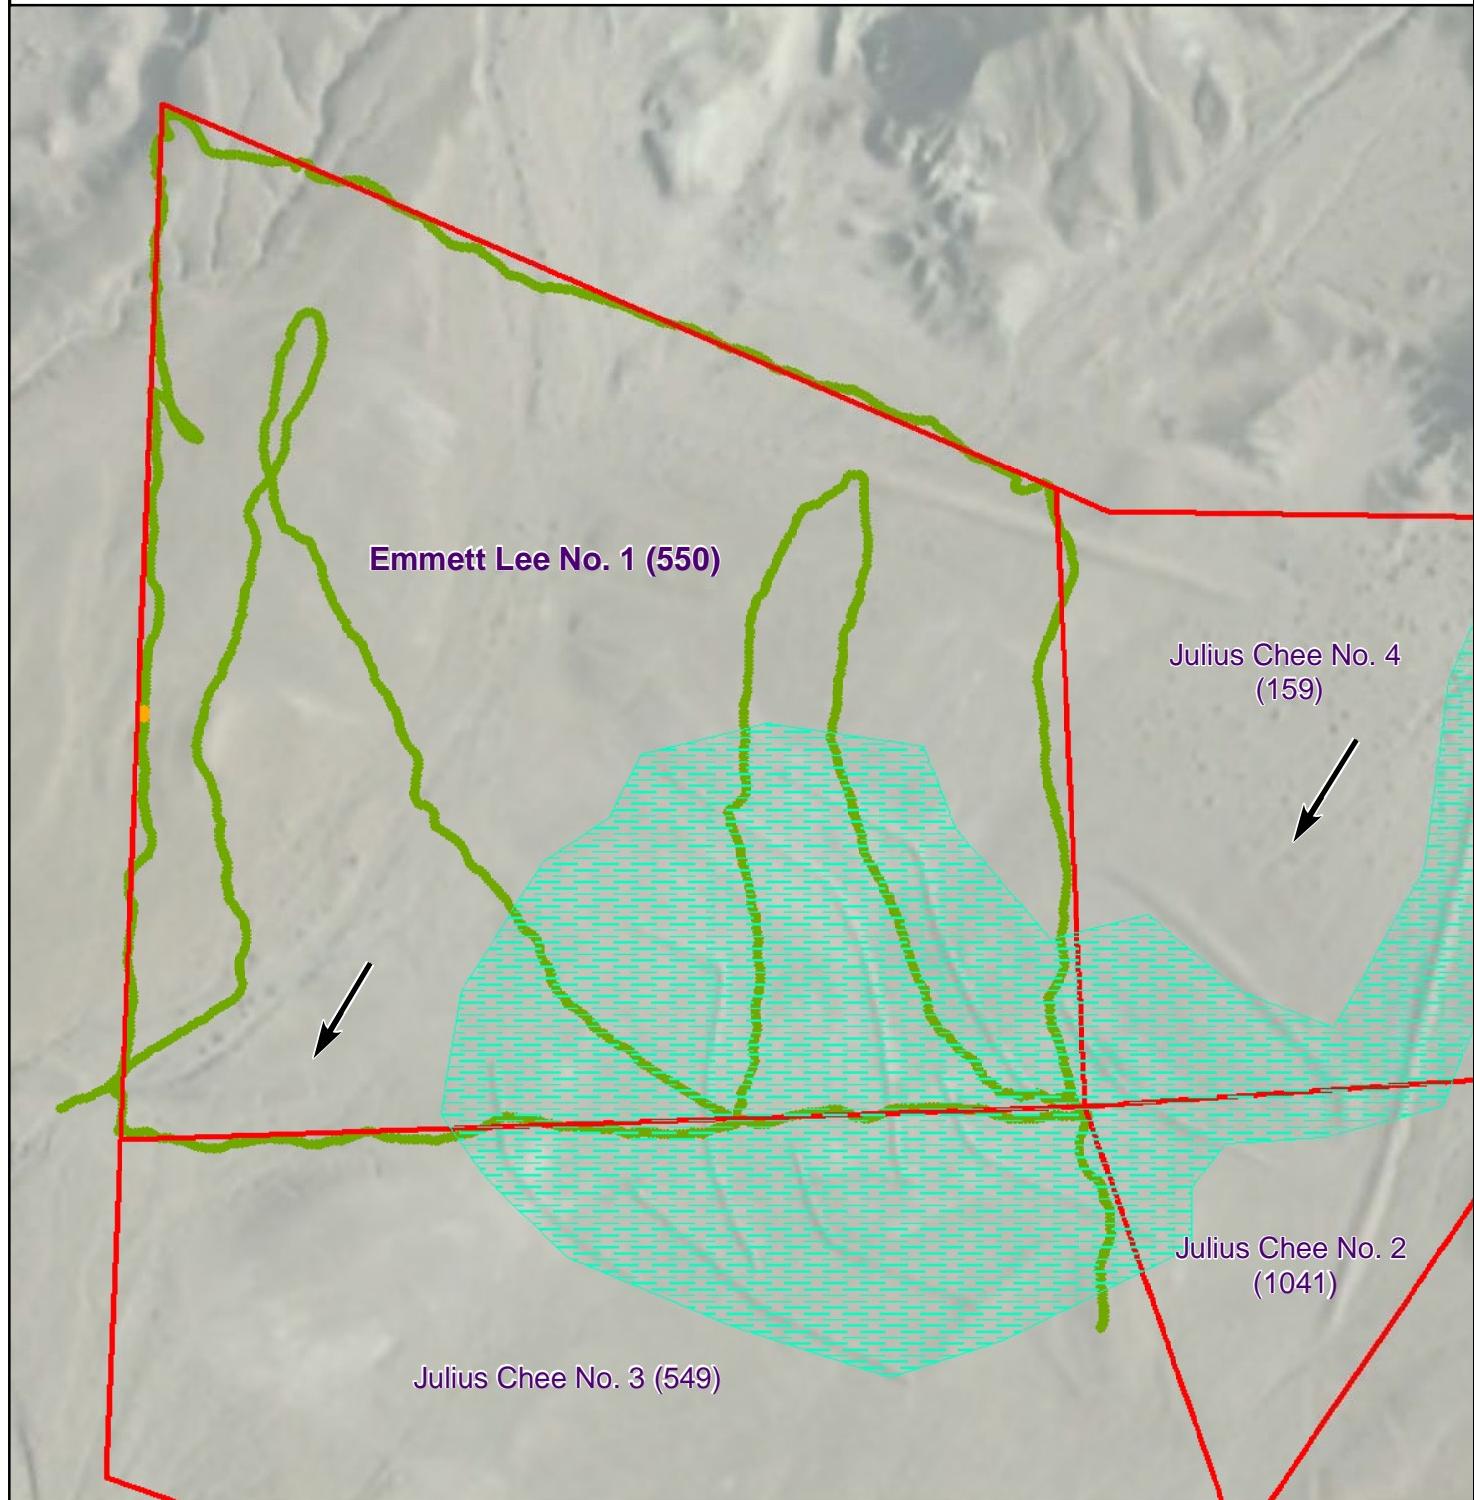
Figure 1 - Gamma Radiation Measurements, Above Two Times Background
Emmett Lee No. 1 (550)
Coalmine Mesa Chapter, Navajo Nation

A total of 2,246 gamma radiation measurements were collected from the mine site, ranging from 9,442 cpm to 22,671 cpm. The measurements are represented in Figures 1 and 2.

Were any gamma radiation measurements collected at the mine greater than two times the site-specific background levels?

Yes

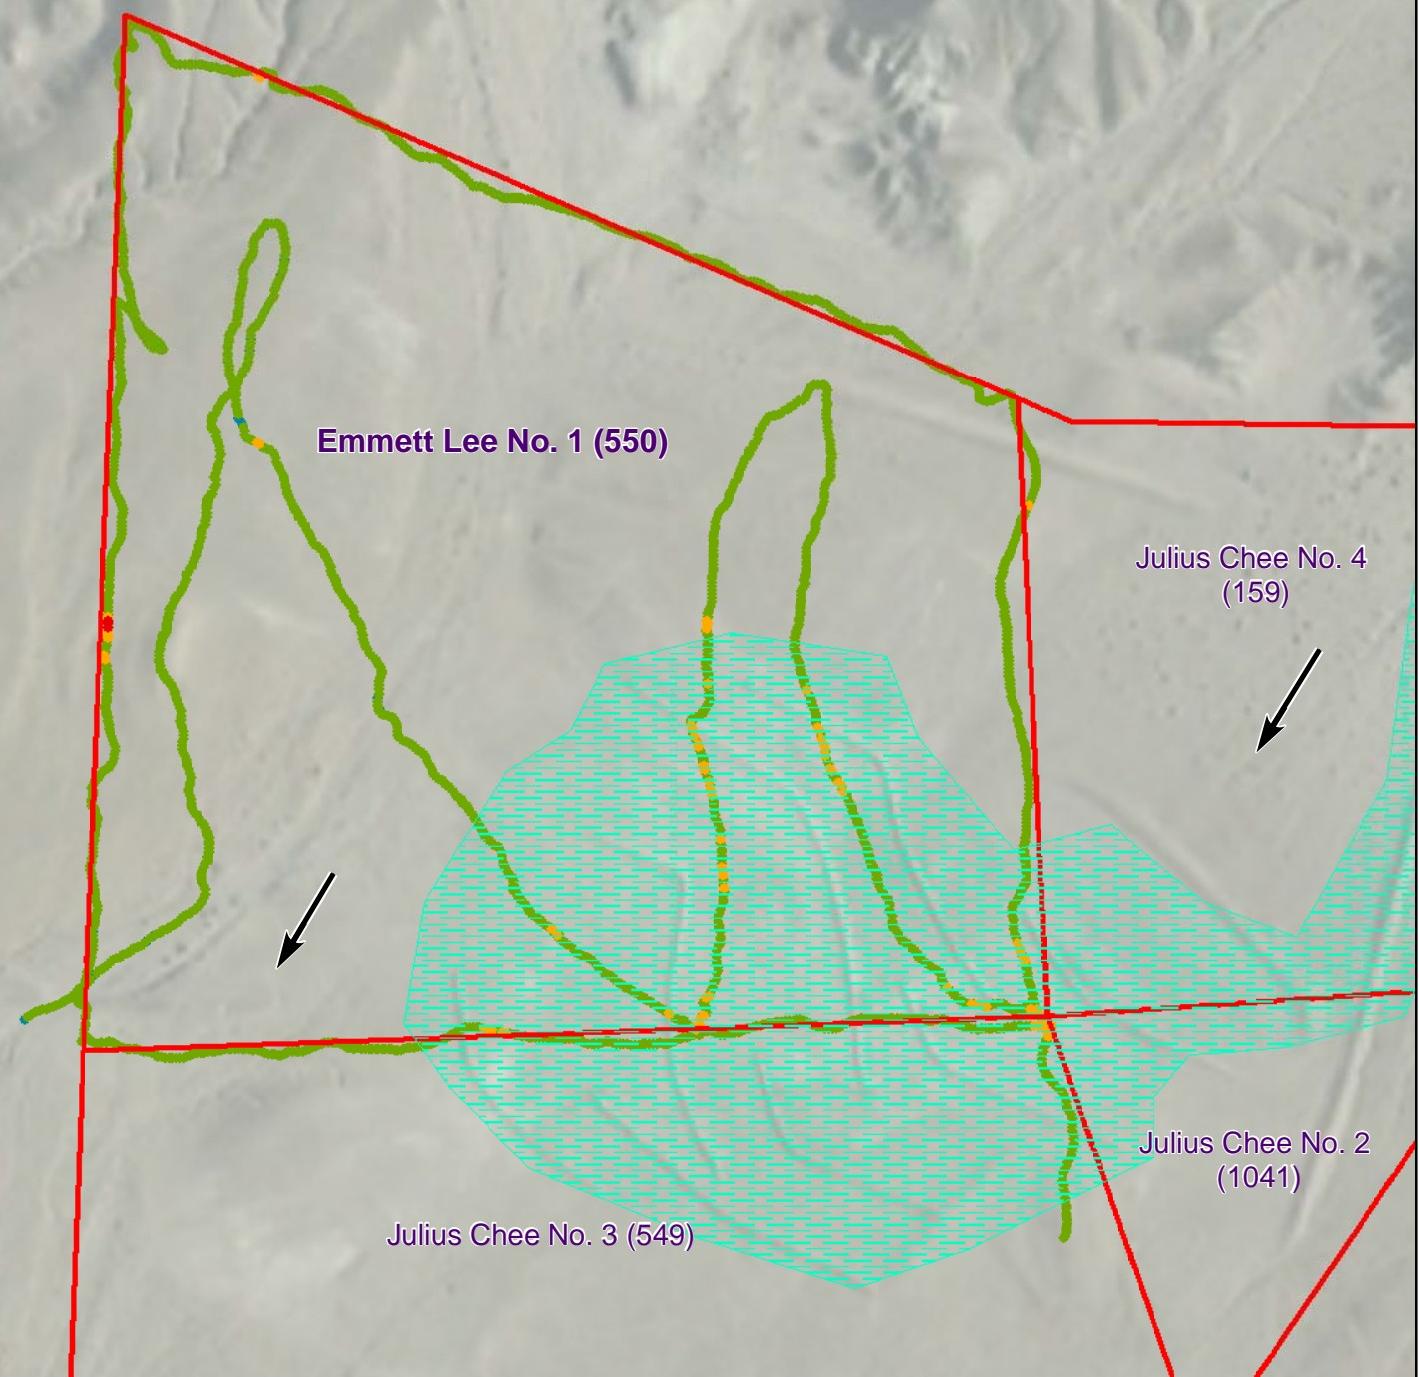
Figure 2 - Gamma Radiation Measurements
Emmett Lee No. 1 (550)
Coalmine Mesa Chapter, Navajo Nation

22,671 counts per minute (cpm)
